**INSPECTION OF WAR-DAMAGED BUILDINGS AND STRUCTURES
BY THE EXAMPLE OF URBAN SETTLEMENT BORODIANKA****O.S. Molodid,**

KNUCA (Kyiv National University of Construction and Architecture) specialists inspected multi-apartment, communal, and administrative buildings in the Borodianka village in the Kyiv region. Based on the results of the surveys, damage to buildings was systematized depending on their causes, namely explosions, and their impact on structures – explosive shock wave, fire, and bullet or shrapnel damage.

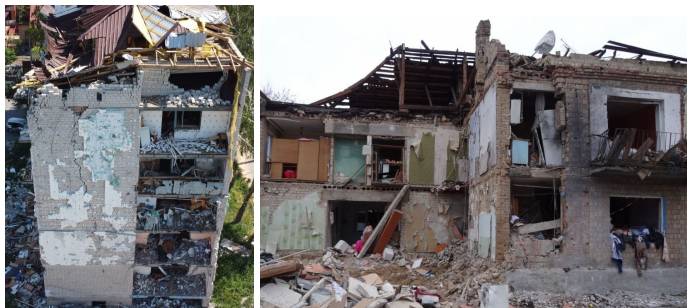
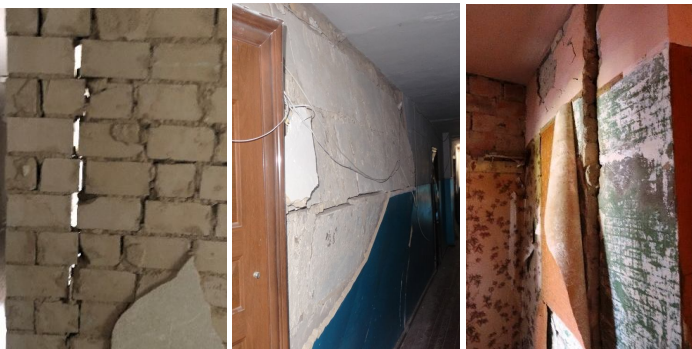
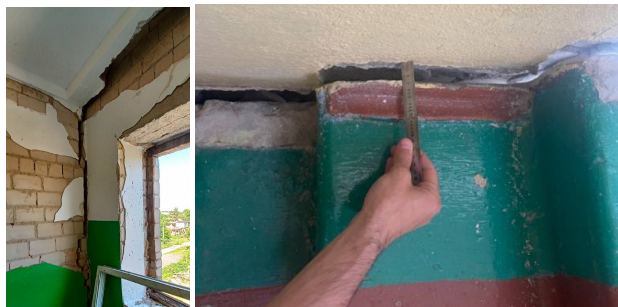
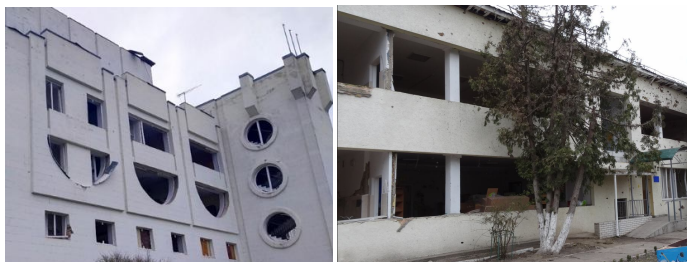
Fig. 2. Defects of damage/destruction of structures from a shock wave

A shock wave from an aerial bomb hitting a building can also cause large-scale destruction to nearby construction sites. The direct damage to load-bearing building structures subjected to the action of the blast wave is damage/destruction of enclosing load-bearing structures (Fig. 2 (a)), damage/destruction of internal non-load-bearing structures (Fig. 2 (b)), change of project position (Fig. 2 (c)), damage to window glasses and frames (Fig. 2 (d)).

In addition to the damage mentioned earlier, the destruction of filling joints between the structures (floor slabs, external and internal wall panels) was often observed due to the shock wave's impact.

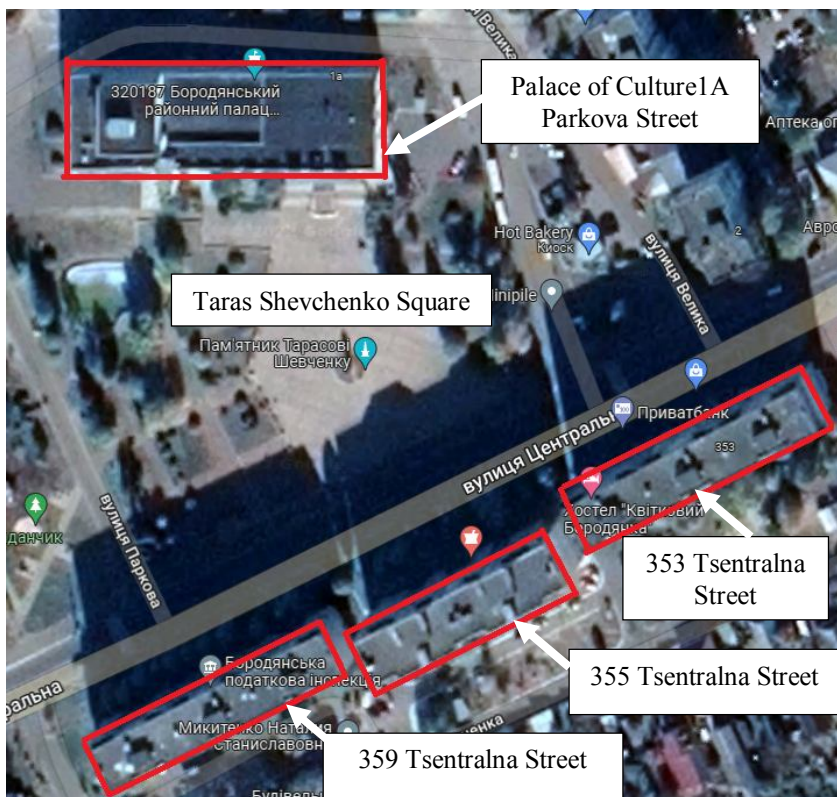
An important factor is also the presence of obstacles in the shock wave path. For example, consider the plot on Tsentralna street within Taras Shevchenko Square (Fig. 3). Behind the square in the open area is the building of the Palace of Culture at the address of 1A Parkova Street, along Tsentralna Street, there are three residential high-rise buildings (numbers 353, 355 and 359) within the square. In the house at the address of 353 Tsentralna Street and 359 Tsentralna Street was the impact of aerial bombs on the central sections of buildings, as a result of which these sections were destroyed, and the outer ones were damaged, making their further safe operation impossible. Instead, the building at the street address 355 Tsentralna street suffered minor damage, and it can be restored by repairing/overhauling. Simultaneously, the distance from the epicenters of the explosions to the damaged building was an average of 30 m. At the same time, the building located on the opposite side of the street (palace of culture), at a distance of more than 100 m, was more affected by the blast wave. As a result, there was a certain displacement (oscillation) of the building (up to 80 mm relative to the vertical) with displacements of load-bearing structures and damage/destruction of

window and door fillings, internal non-load-bearing structures, and equipment.

Fig. 3. Situational plan of the location of the Palace of Culture in relation to residential buildings destroyed by an aerial bomb

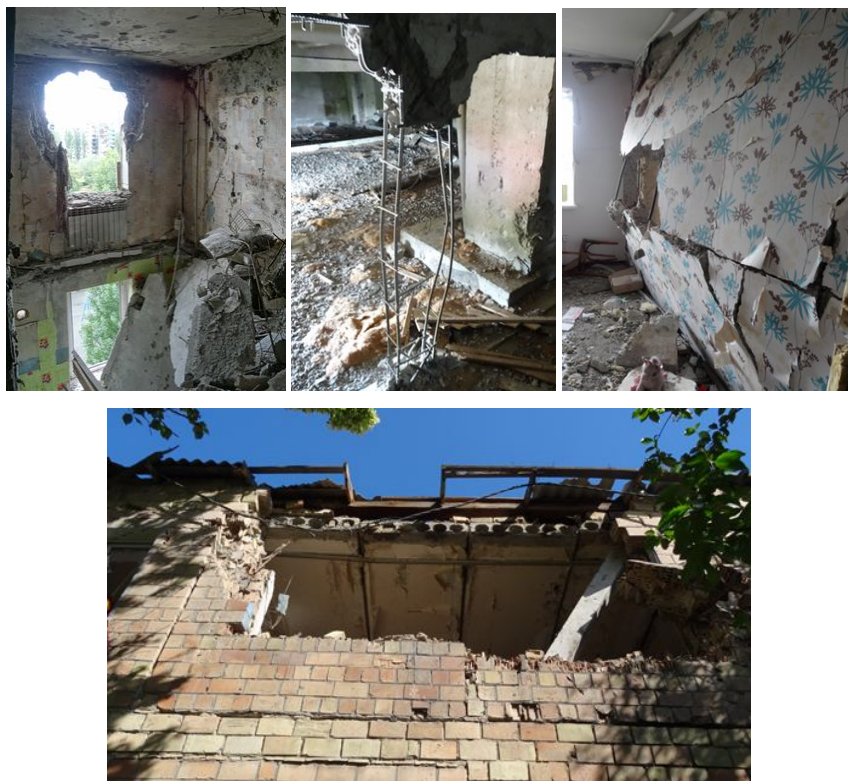
The following in terms of the destructive effect on buildings can be attributed to damage by multiple launch rocket systems (MLRS), artillery weapons, and tanks (Fig. 4). Destruction and damage to structures from the impact of projectiles from the specified weapons are usually smaller than when an aerial bomb is hit and causes local damage to the building with the destruction of individual supporting structures.

Fig. 4. Damage to structures due to the impact of projectiles from an MLRS, artillery, and tanks

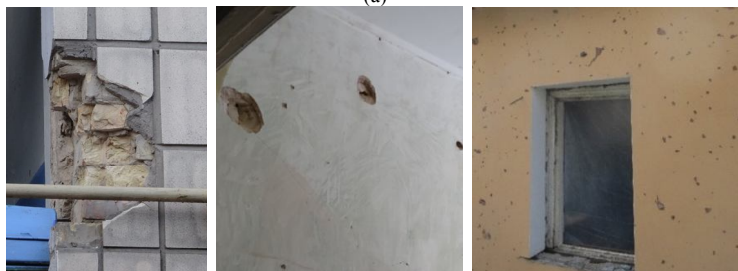
Building structures suffer minor damage when they are hit by armored personnel carriers (APCs) and small arms (Fig. 5 (a)); and shrapnel (Fig. 5 (b)).

Fig. 5. Damage to structures due to hits from APCs, small arms (a), and shrapnel damage (b)

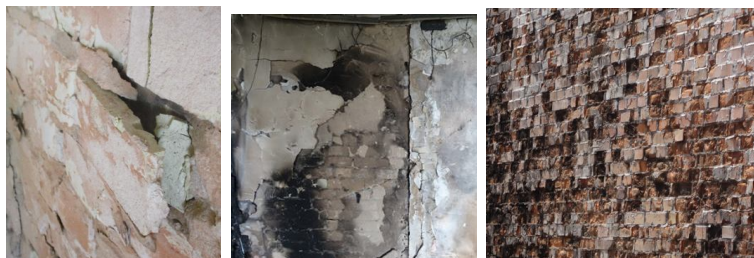
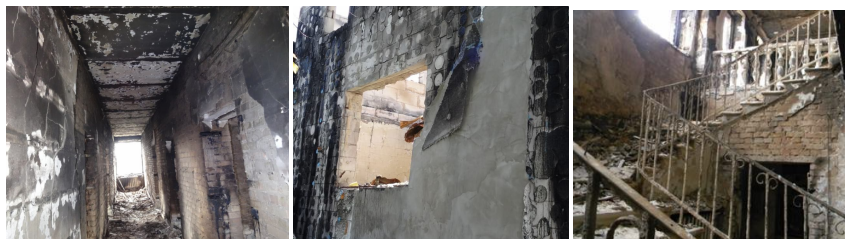
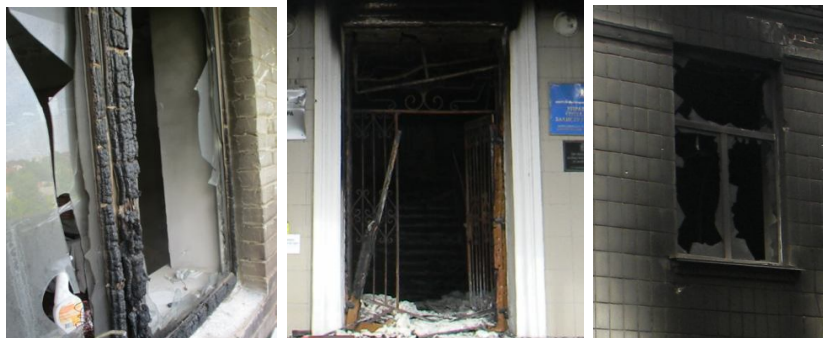
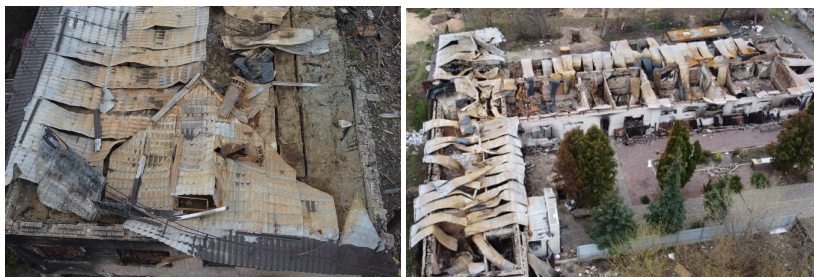
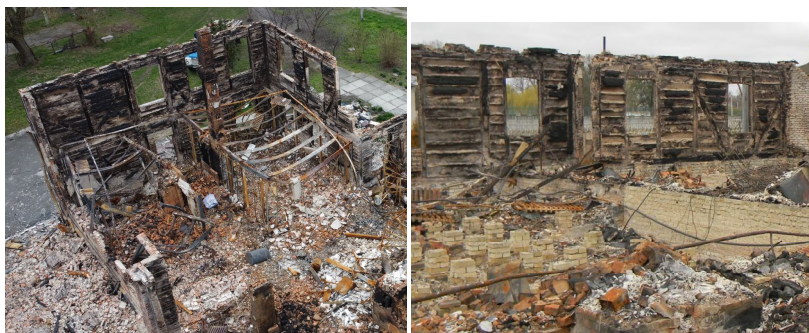
irreversible consequences. The typical primary damage to structures exposed to high temperatures (thermal impact) as a result of fires was: fire damage to structures - concrete (especially visible in the lower zone of round hollow floor slabs along voids) (Fig. 6 (a)) and bricks (Fig. 6 (b)); damage to finishing layer (Fig. 6 (c)); burning and melting of a window and door frames and their filling (Fig. 6 (d)); destruction of the roof (Fig. 6, e); the destruction of wooden walls and ceilings (Fig. 6 (f)– the wooden building, that was faced with bricks on the outside).

Fig. 6. Damage/destruction of structures due to fire

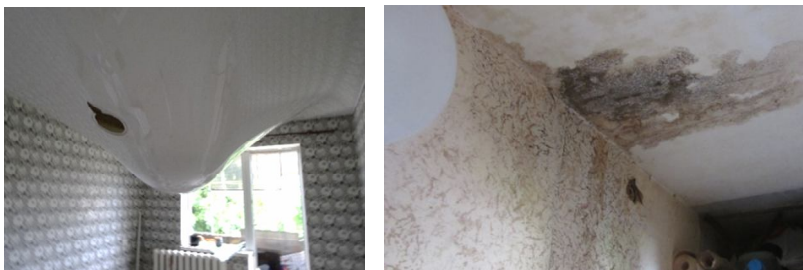
It should be noted that as a result of damage/destruction of external enclosing structures (roof, windows, walls), precipitation enters inside the premises (Fig. 7). As a result, significant soaking of construction structures is observed. Over time, under the influence of such a negative factor, building structures' physical and mechanical properties will deteriorate, particularly when the temperature of the external environment changes.

Fig. 7. Impact of precipitation on building structures

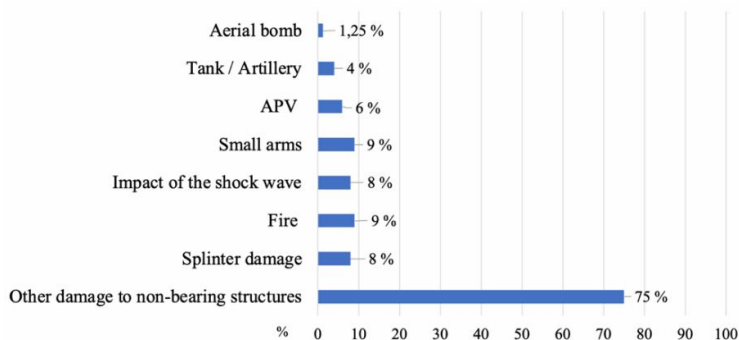
As a result of the performed work, it was established that all the examined buildings (about 400 pieces) suffered various damages due to the impact on them of various weapons. Based on the analysis of the obtained data, a histogram (Fig. 8) was constructed, which shows the percentage ratio of damage to construction objects by various types of weapons.

Fig. 8. Damage to construction objects by various types of weapons

So then, it can be seen from the histogram that about 1.25% of the buildings were destroyed due to aerial bombs hitting them. About 4% of the buildings suffered partial destruction and other significant damage (declination from the design position, distortion, cracks, holes, et cetera) due to being hit by shells from tanks or other artillery weapons. 6% of buildings were damaged (holes, destruction of individual structures, cracks, destruction, and damage of masonry, et cetera) due to being hit by shells from APC. Moreover, another 9% of buildings were damaged (chips on the facades, damage to the filling of windows and doors, et cetera) from small arms. At the same time, about 8% of the buildings were damaged (distortion, deviation from the design position, cracking, destruction, and damage of window and door frames with filling and furnishing layer, et cetera) due to the impact of the shock wave. Another 9% of buildings were damaged due to fire (fire/thermal damage to bricks and reinforced concrete structures, thermal elongation of reinforcement, damage to the finishing layer, et cetera). About 8% of the buildings suffered various splinter damage (chips, damage to the protective layer, damage to the furnishing layer, et cetera). Nevertheless, about 75% of the buildings suffered other damage to non-bearing structures, including damage to windows and doors, as a result of illegal actions by looters.
